PROJECT
STATE OF CALIFORNIA, DGS
BOE ASSESSMENT

DESCRIPTION
WATER DAMAGE
SURVEY

LOCATION
4TH FLOOR

SHT NO. 5
SHT NAME A4

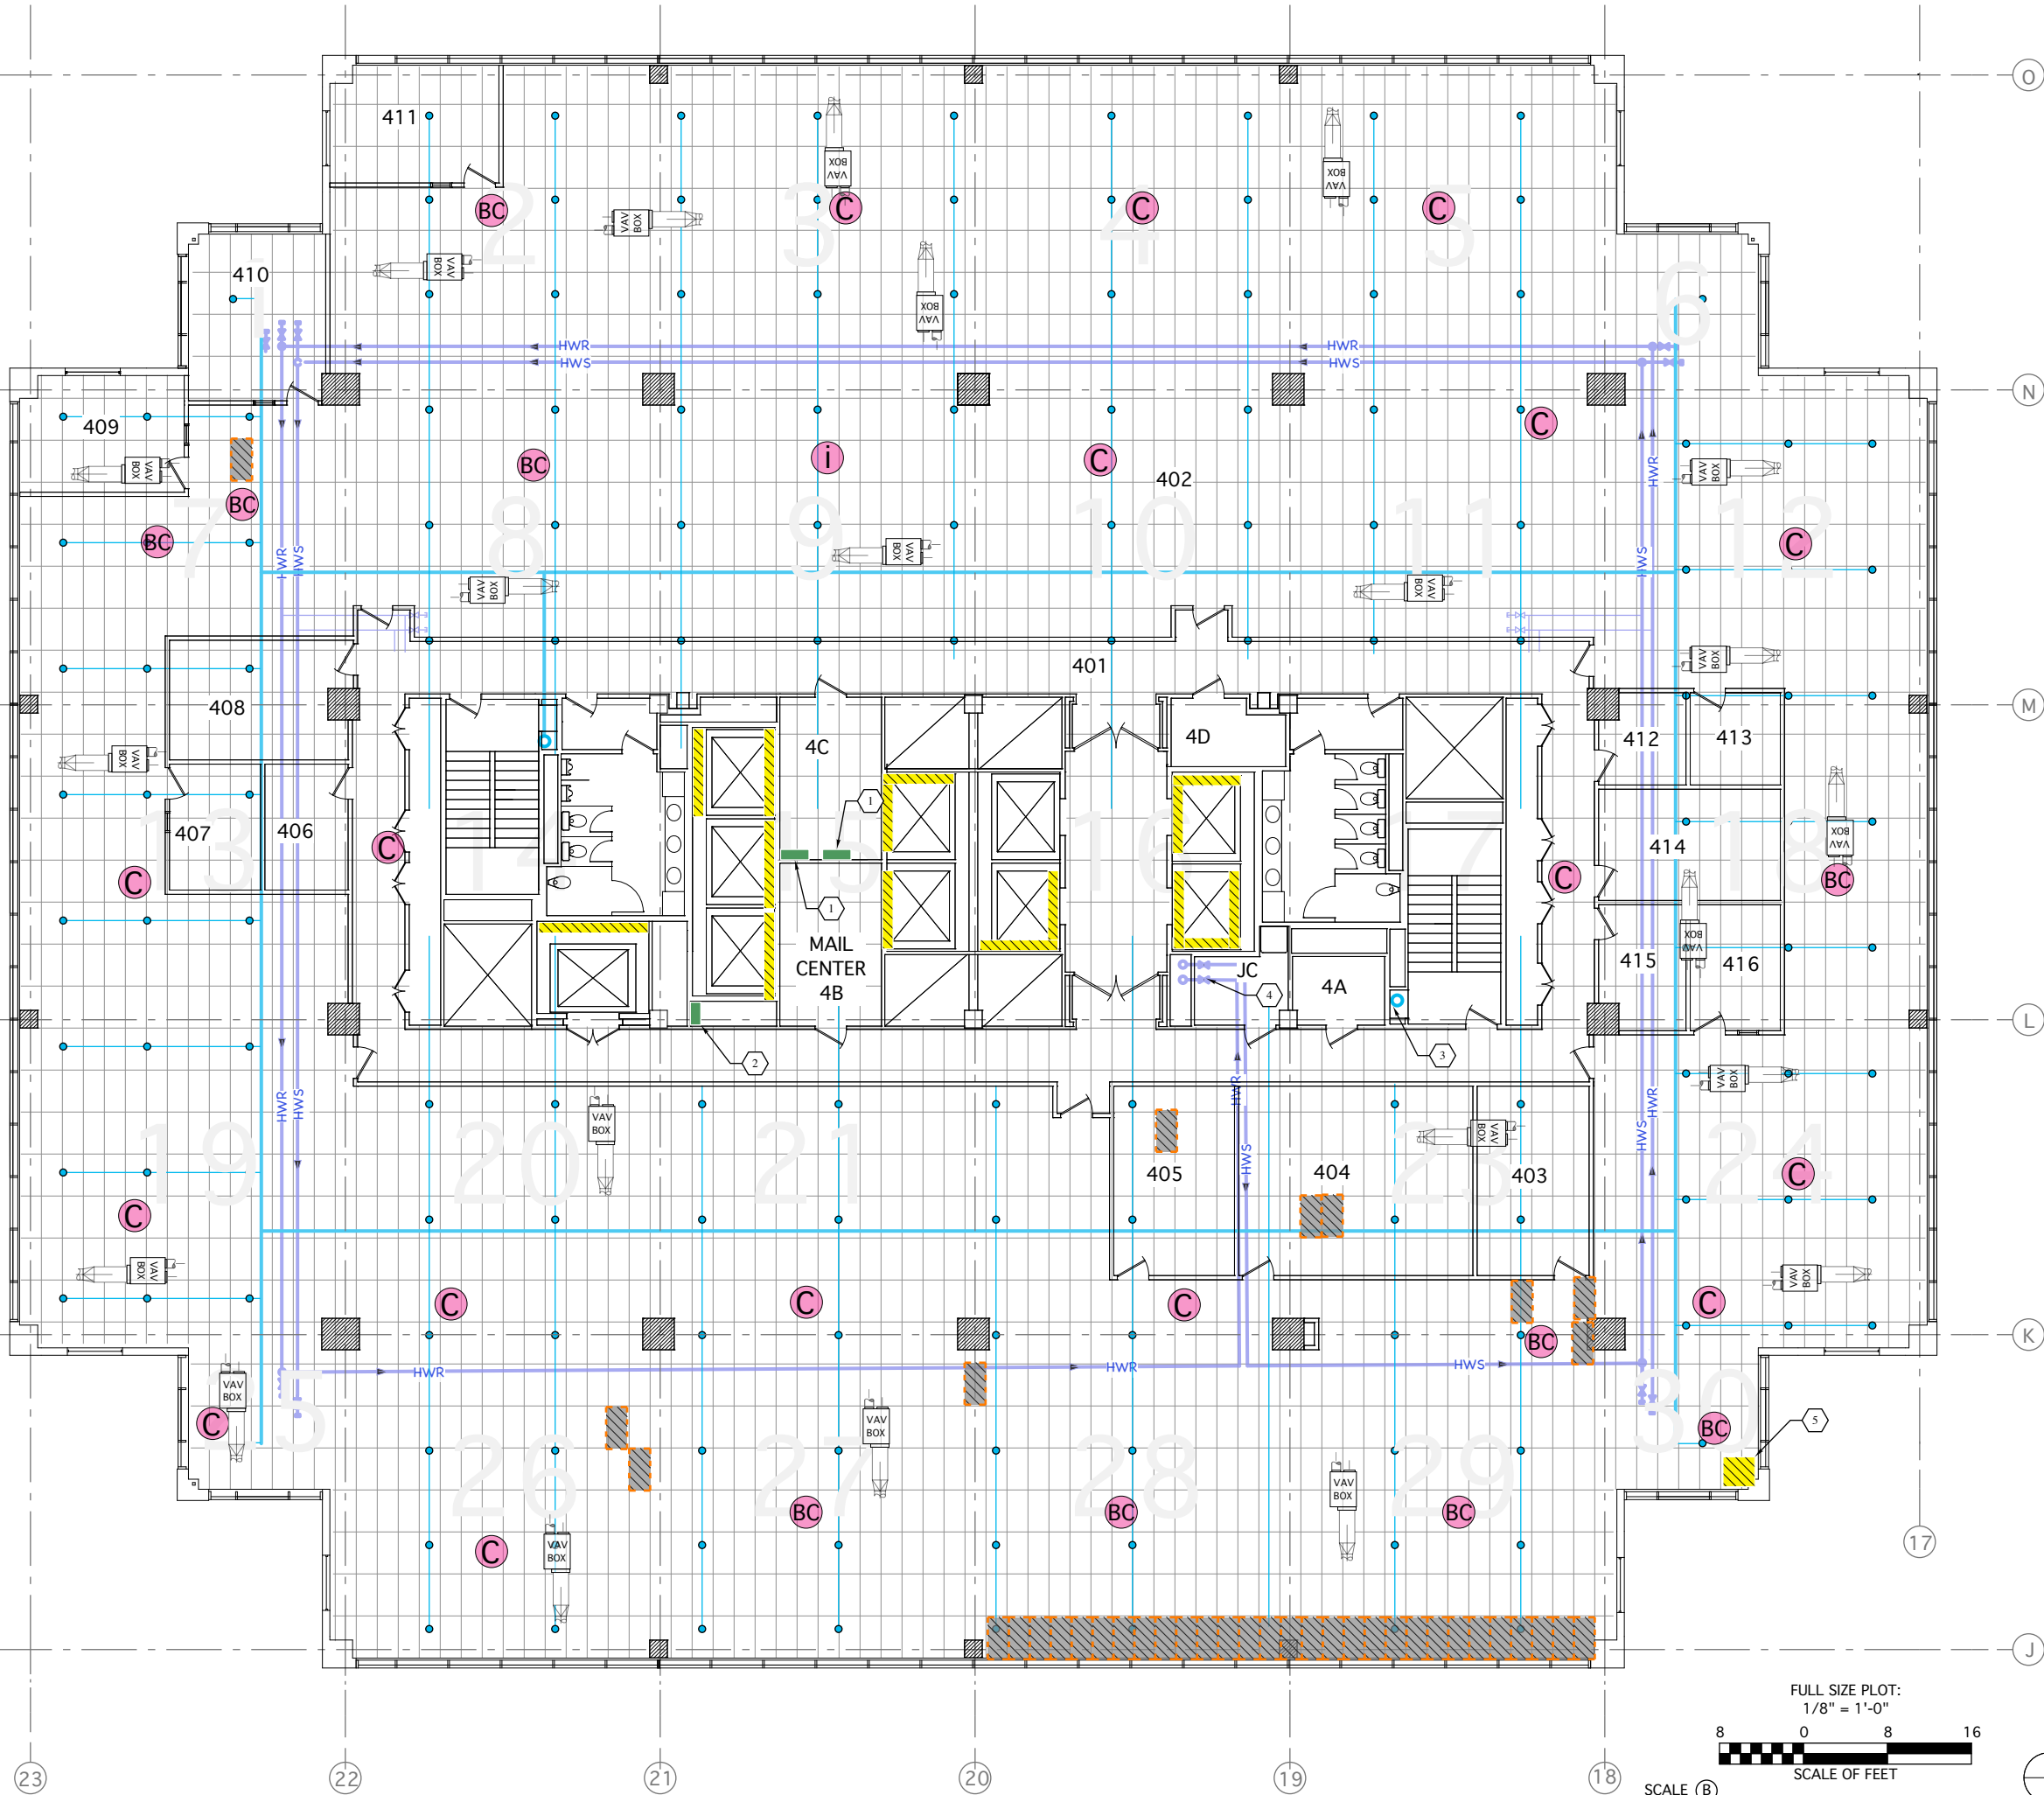
- 1 L.5/21.5 3 SF VMG (CURRENT)
- 2 L/21 2 SF VMG (CURRENT)
- 3 WEeping FITTING (CURRENT)
- 4 WEeping VALVE (CURRENT)
- 5 K.5/17.5 WS ON CARPET NEAR PLANT (CURRENT)
- 6
